ANNUAL INSPECTION REPORT FOR VIRGINIA REGULATED IMPOUNDING STRUCTURES

Name of Dam: Possum Point Power Station Oil Water Treatment Basin Dam Inventory Number: NA
Owner's Name: Dominion Generation Location-County/City: Prince William County
Contact Person (if different from above): Michael Winters, P.E.
Owner's Address: 5000 Dominion Boulevard, Glen Allen, VA 23060 Hazard Classification: Low
Name of reservoir: Possum Point Power Station Oil Water Treatment Basin
Purpose of reservoir: contains coal ash
Telephone No.: (Residential) 804-347-9451 (Business) 804-273-2376, cell: 804-347-9451
Other means of communication: michael.j.winters@dom.com

Date of This Inspection April 2, 2014
Date of Last Inspection unknown

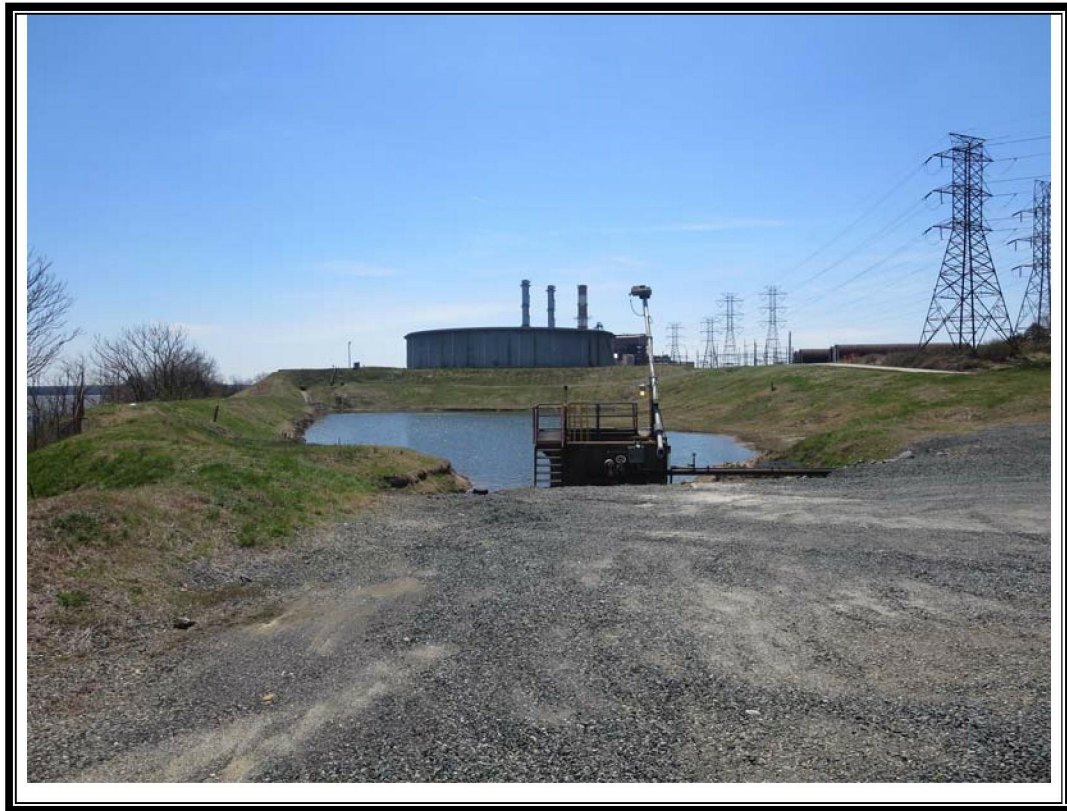
PHOTO 1
Overview looking south.

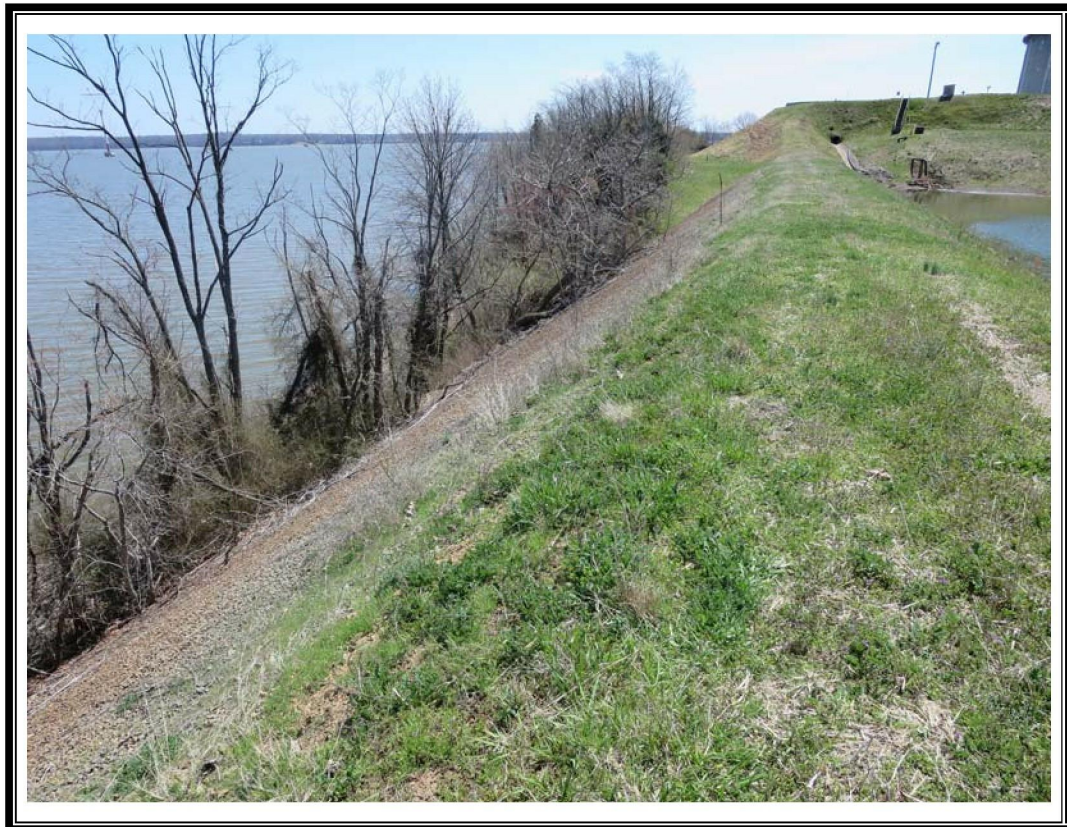
- a. Woody vegetation discovered? Heavy

PHOTO 2
Downstream slope.

Recommendations: Perform hydraulics and hydrology analysis. Remove trees from the downstream slope.

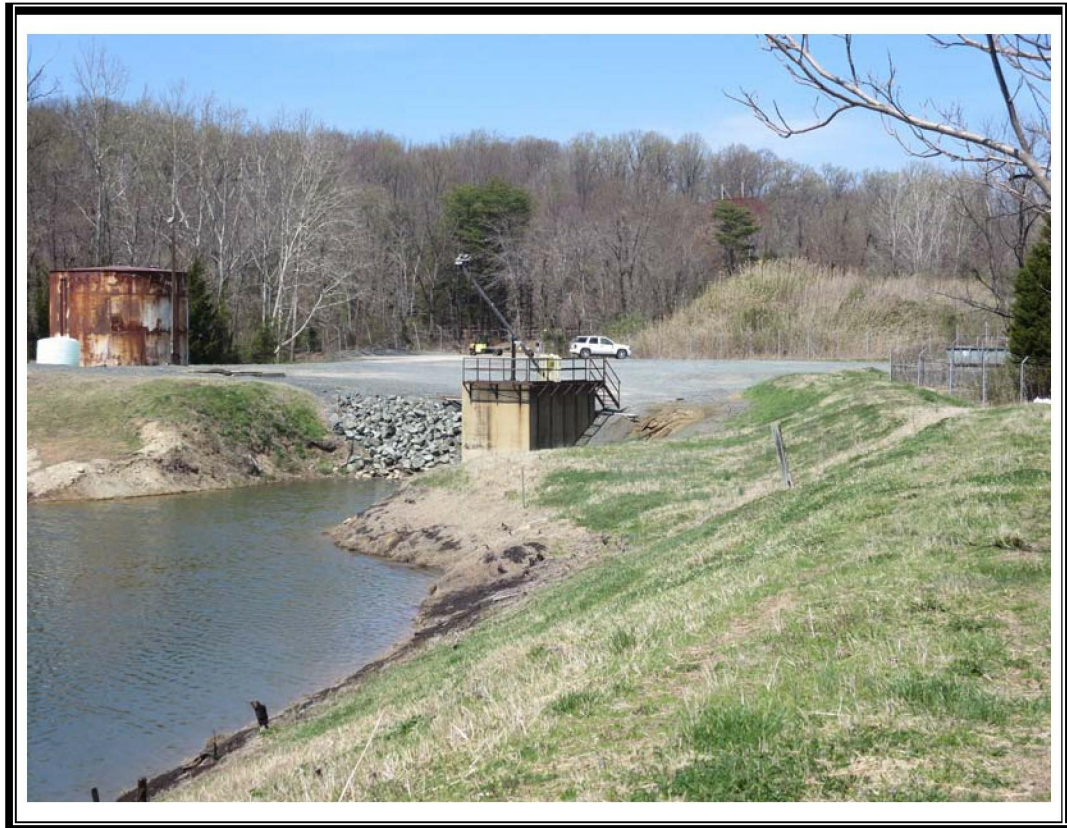
PHOTO 3
Upstream slope and outlet structure.
